# FINAL PRELIMINARY ASSESSMENT AND SITE INSPECTION OF PER- AND POLYFLUOROALKYL SUBSTANCES

## Fort Rucker, Alabama

Prepared For:  
U.S. Army Corps of Engineers, Baltimore District  
2 Hopkins Plaza  
Baltimore, Maryland 21201

November 2022

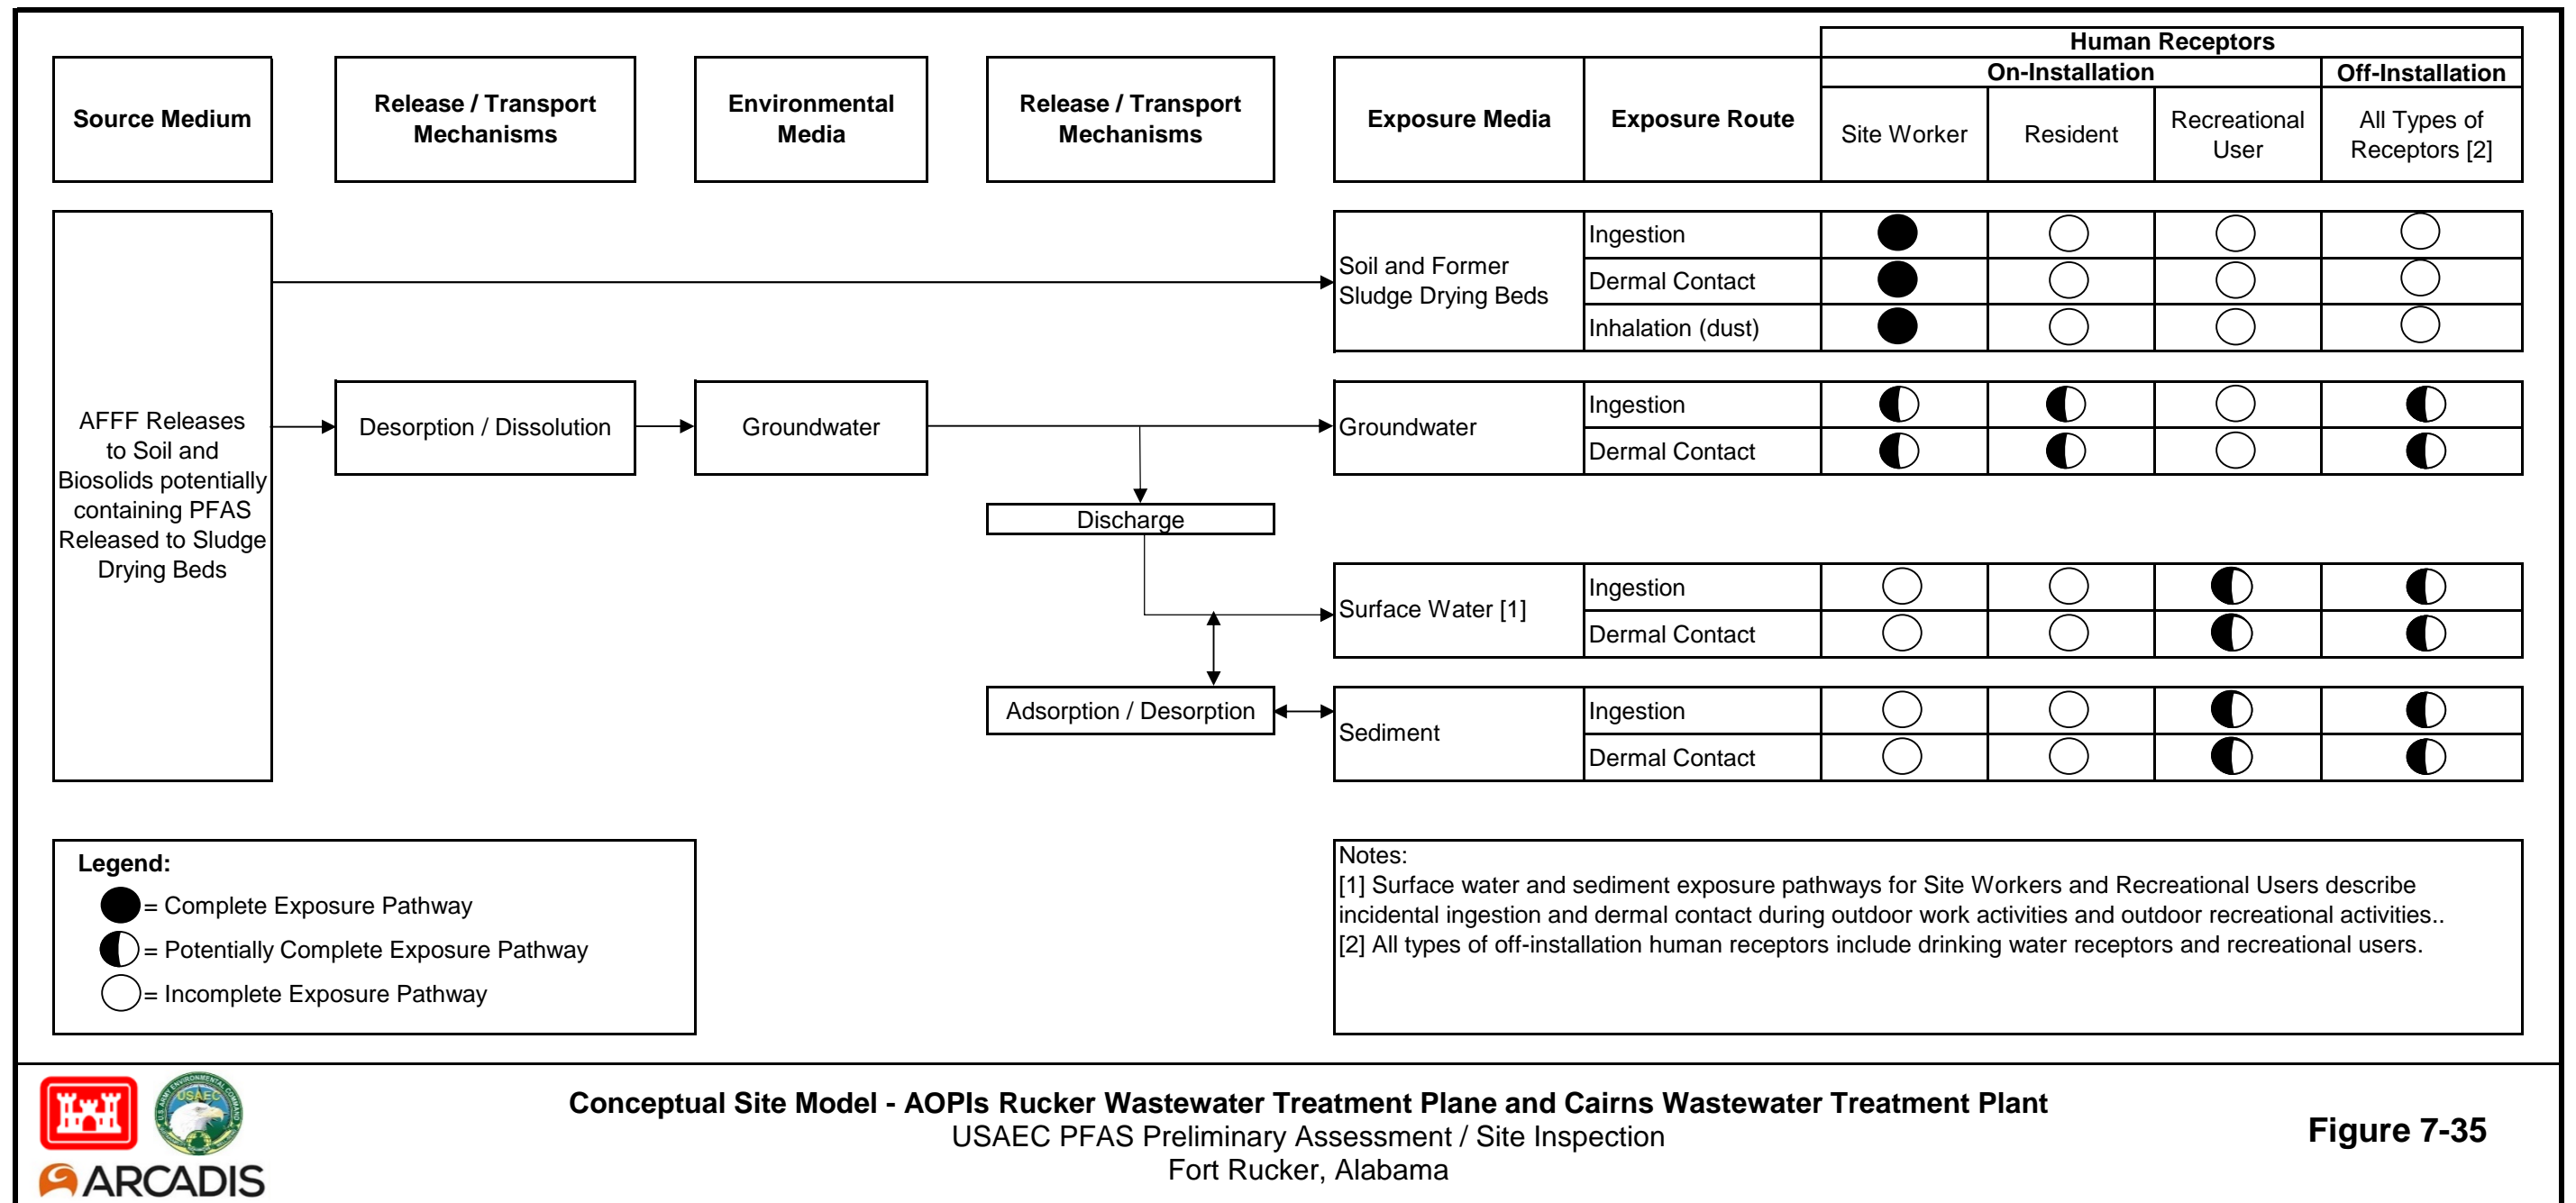
**Figure 7-35**

**Conceptual Site Model - AOPs Rucker Wastewater Treatment Plant and Cairns Wastewater Treatment Plant**  
 USAEC PFAS Preliminary Assessment / Site Inspection  
 Fort Rucker, Alabama

Two WWTPs are in service at Fort Rucker, both of which are maintained by American Water. The main WWTP is located on the main installation and a smaller WWTP is located at the Cairns AAF. The Cairns WWTP received an AFFF release to the environment on 23 September 2019 (volume unknown). The aerators at the Cairns WWTP caused the AFFF to foam which may have overflowed into the surrounding soil. In 2014, a contractor emptied the Hangar 25165 AFFF concentrate tank into the sanitary system. This event resulted in a large secondary release of PFAS-containing materials at the main WWTP.
