Figure 28-B
Range Operations
Fort Rucker
Dale County, Alabama

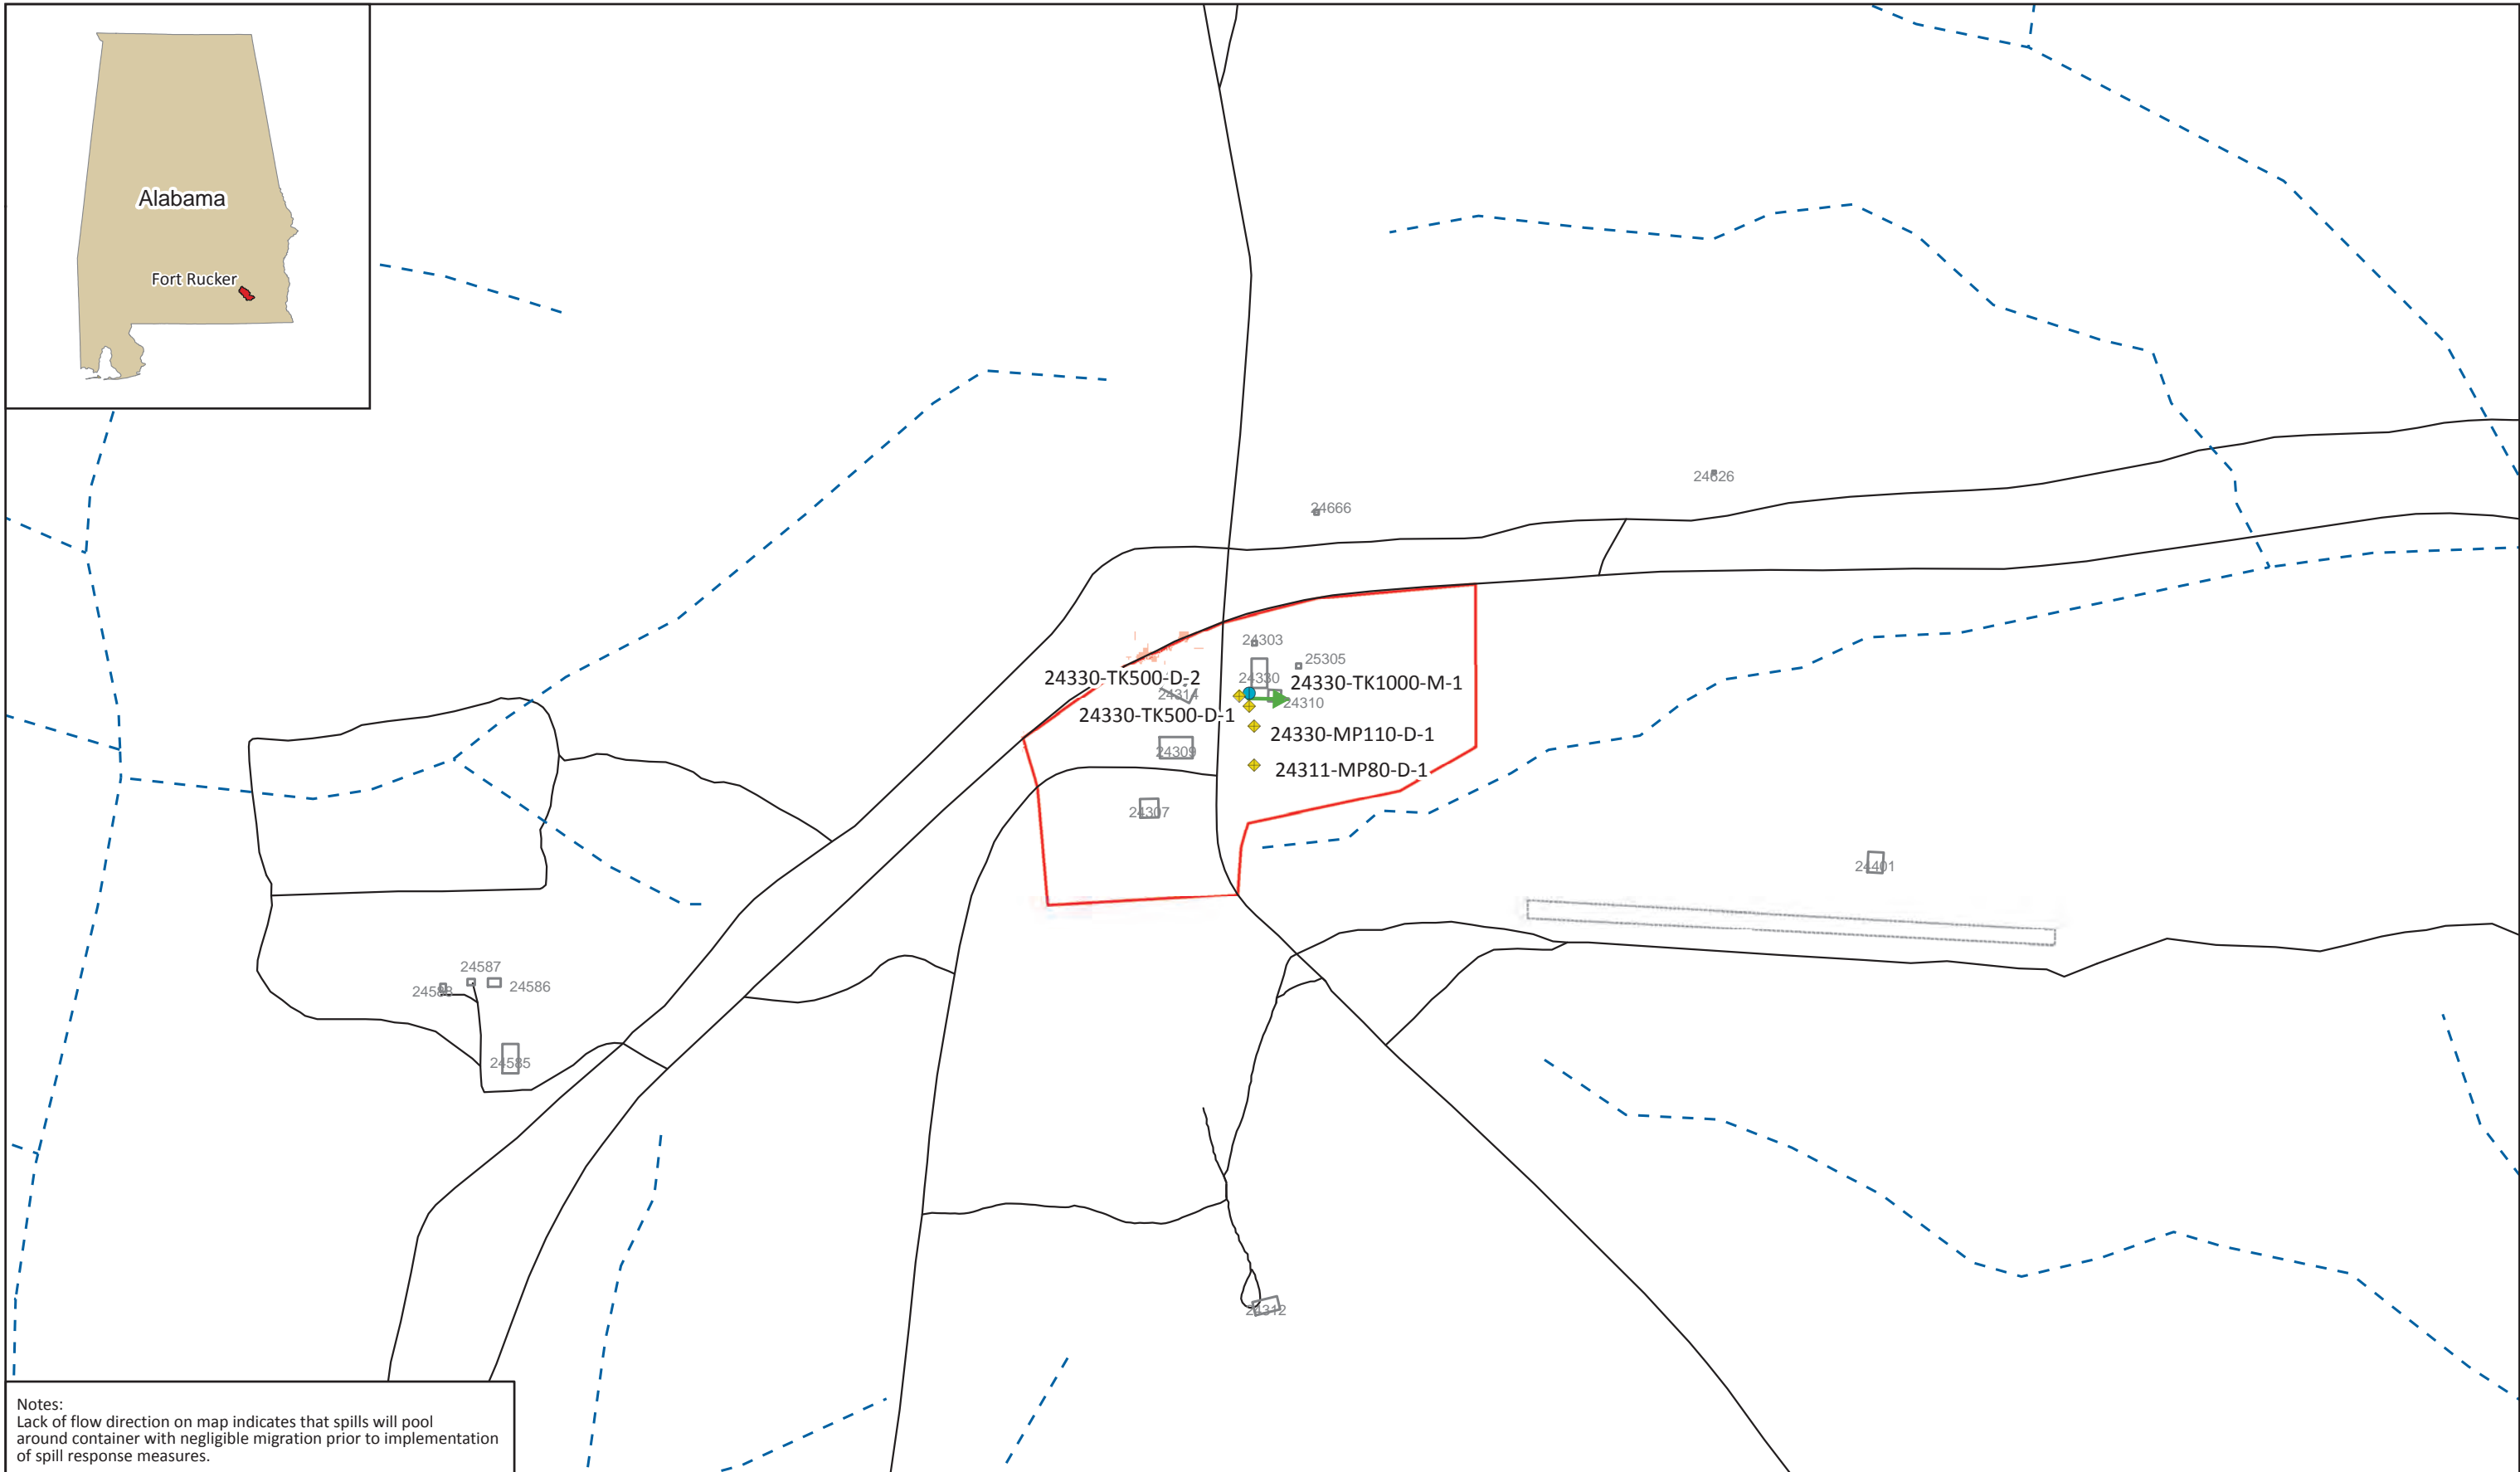
Notes:
Lack of flow direction on map indicates that spills will pool around container with negligible migration prior to implementation of spill response measures.
