**Figure 36-A**  
**Tabernacle Stagefield**  
**Fort Rucker**  
**Coffee County, Alabama**

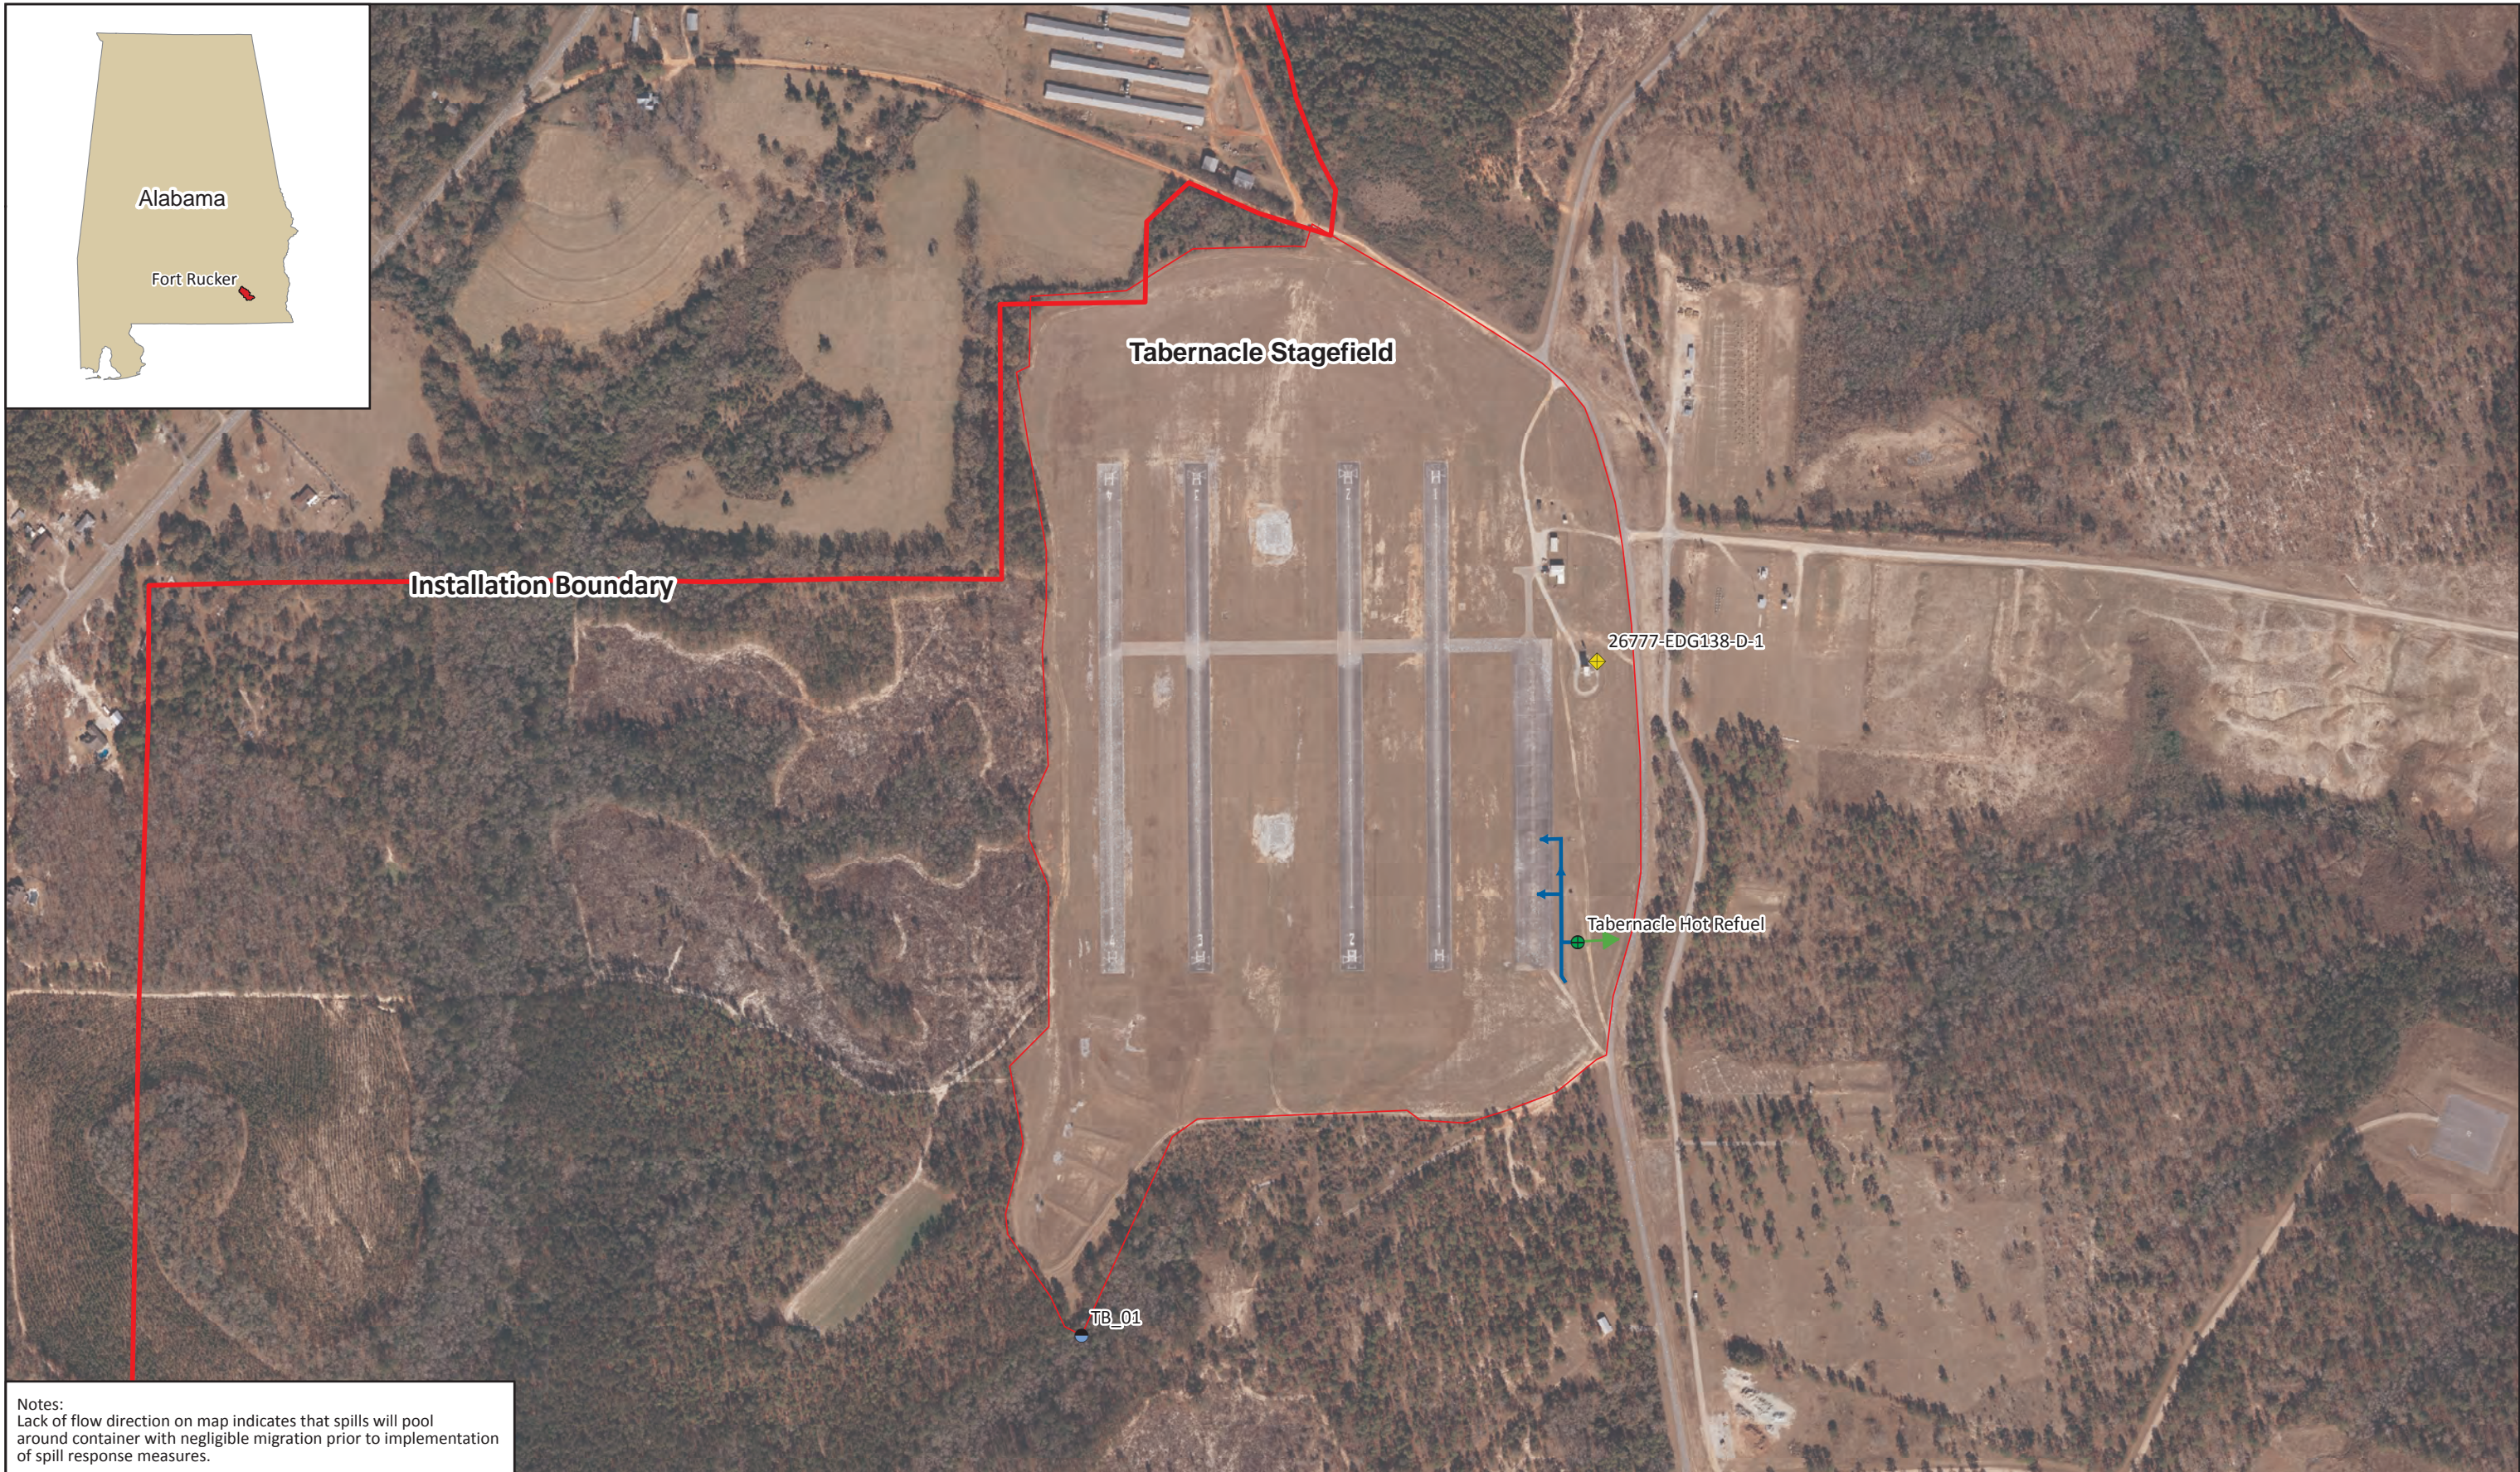
Notes:  
Lack of flow direction on map indicates that spills will pool around container with negligible migration prior to implementation of spill response measures.
